## HEALTH RISK FROM EXPOSURE TO HYDROGEN SULPHIDE GENERATED BY RECLAMATION ACTIVITIES IN THE MYDLOVARY AREA

*Jana Chumchalová, Svetlana Remelgas, Siarhei Skoblia, Martin Kubal, Karel Ciahotný, Radek Škarohlíd, Marek Martinec*

*University of Chemistry and Technology Prague, Technická 5, 166 28 Prague 6, Czech Republic  
e-mail:jana.chumchalova@vscht.cz*

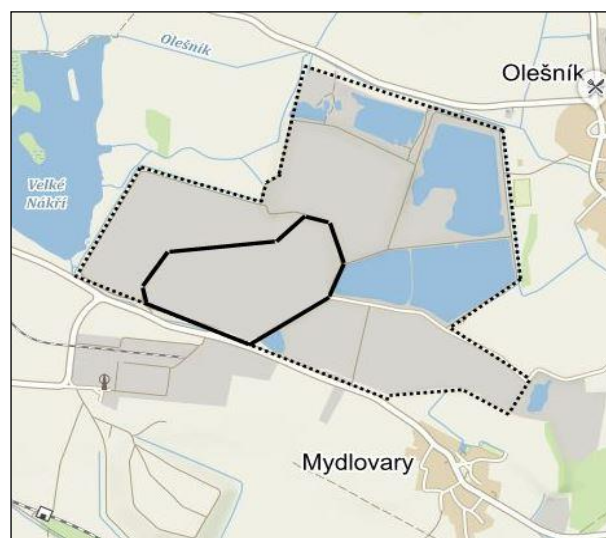
**Figure 1:** General location of MAPE impoundments area with sludge lagoon K IV/R

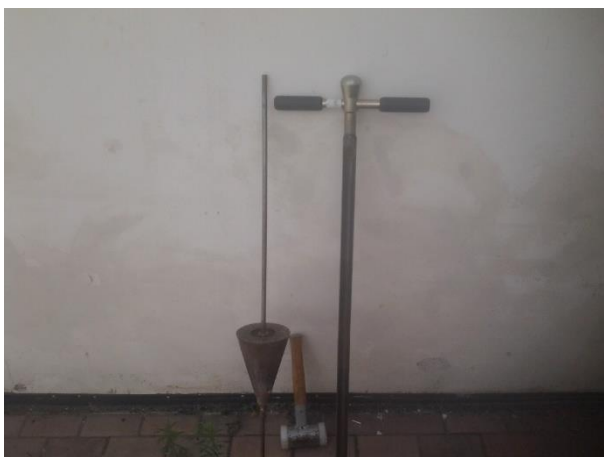
The atmogeochemical monitoring was based on subsurface air sampling which was carried out by the sampling set shown at Figure 2. Steel hollow sampling tube was hammered into the subsurface to the depth of about 0.5 - 0.7 m and sealed in its upper part by aluminium cone. The tube was then connected to the Multitec 540 device (Hermann Sewerin GmbH) equipped with detector of hydrogen sulphide. Atmogeochemical monitoring was carried out in a preliminary sequence first which was followed by detailed mapping. Preliminary atmogeochemical search (28.03.2018 and 21.5.2018) was aimed to get approximate knowledge on hydrogen sulphide distribution and concentrations in the subsurface air. Detailed search (14.6.2018) was performed to provide detail concentration maps on the K IV/R lagoon area.

**Figure 2:** Sampling set for atmogeochemical survey

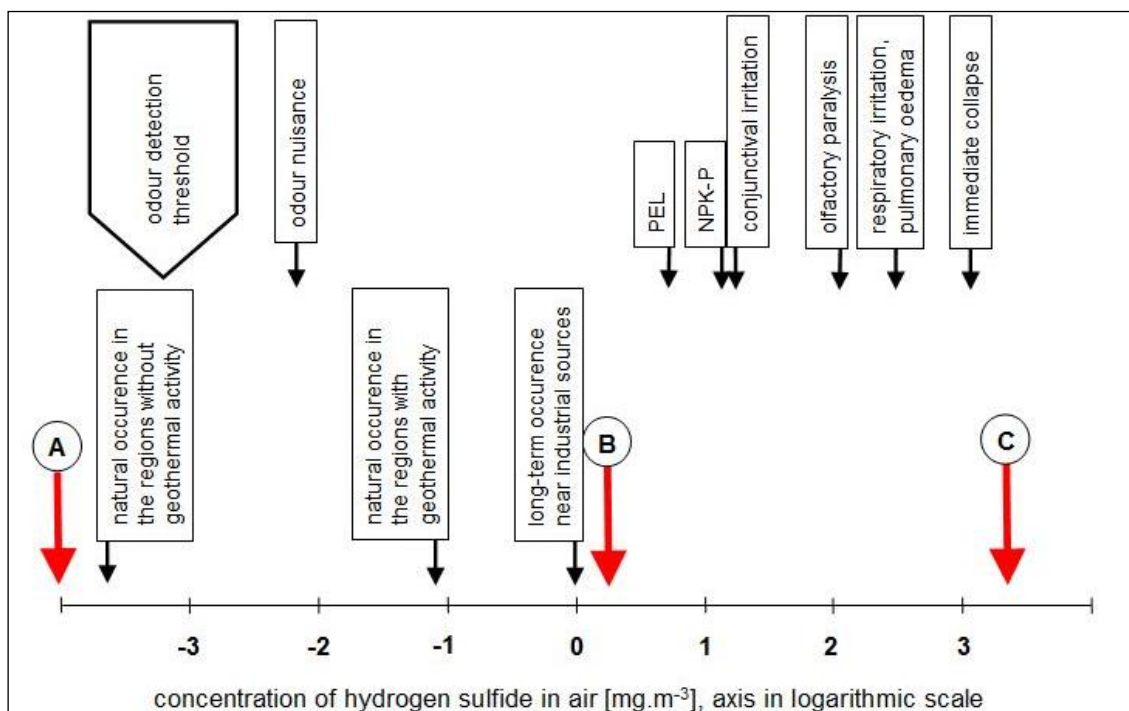
The measured concentrations of hydrogen sulphide may further be compared with the hydrogen sulphide sensory effects and its toxicological limits as summarized in Figure 4.

**Figure 4:** Hydrogen sulphide sensory effects and its toxicological limits (red arrow (A): air hydrogen sulphide concentration measured for long-term sampling at the Mydlovary village area; red arrow (B): air hydrogen sulphide concentration measured for lagoon perimeter; red arrow (C): the highest hydrogen sulphide concentration measured in the subsurface air at the lagoon K IV/R)

threshold or naturally occurring hydrogen sulphide concentrations (see Figure 4). Much higher hydrogen sulphide concentrations - units of  $\text{mg.m}^{-3}$  - detectable at the K IV/R lagoon perimeter may be considered as potentially hazardous. On the other hand, there are no residents at the lagoon territory, only workers to whom the legal limits for occupational exposition apply.

Figure 4 gives a graphic representation of the variety of possible effects of hydrogen sulphide on human health in relation to its air concentrations, along with the above presented concentrations detected in the centre of the contaminated subsurface air pocket in the lagoon K IV/R, at the perimeter of the lagoon, as well as at the territory of Mydlovary village. It clearly follows from Figure 4 that no adverse effects may be expected towards the Mydlovary inhabitants in relation to the hydrogen sulphide air concentration measured in October 2017. Similarly, no disagreements were identified with the occupational exposition limits for the workers moving inside the lagoon territory. Thus, the future attention should mainly be directed to the high subsurface air concentrations, which might indicate the existence of undesirable chemical and/or microbiological processes.
