## HEALTH RISK FROM EXPOSURE TO HYDROGEN SULPHIDE GENERATED BY RECLAMATION ACTIVITIES IN THE MYDLOVARY AREA

*Jana Chumchalová, Svetlana Remelgas, Siarhei Skoblia, Martin Kubal, Karel Ciahotný, Radek Škarohlíd, Marek Martinec*

*University of Chemistry and Technology Prague, Technická 5, 166 28 Prague 6, Czech Republic  
e-mail:jana.chumchalova@vscht.cz*

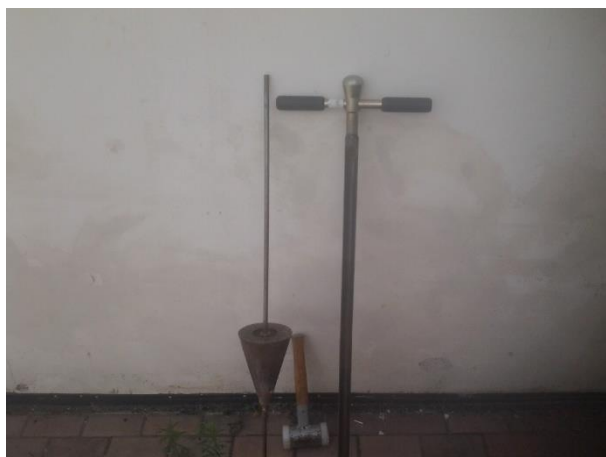
The atmogeochemical monitoring was based on subsurface air sampling which was carried out by the sampling set shown at Figure 2. Steel hollow sampling tube was hammered into the subsurface to the depth of about 0.5 - 0.7 m and sealed in its upper part by aluminium cone. The tube was then connected to the Multitec 540 device (Hermann Sewerin GmbH) equipped with detector of hydrogen sulphide. Atmogeochemical monitoring was carried out in a preliminary sequence first which was followed by detailed mapping. Preliminary atmogeochemical search (28.03.2018 and 21.5.2018) was aimed to get approximate knowledge on hydrogen sulphide distribution and concentrations in the subsurface air. Detailed search (14.6.2018) was performed to provide detail concentration maps on the K IV/R lagoon area.

**Figure 2:** Sampling set for atmogeochemical survey
